▶ WINTER 2012

CNDUIT

INSPECTING THE Hone Quarry Dam Conduit Structures

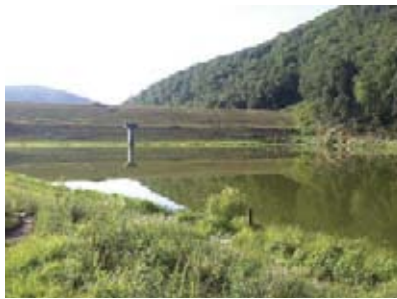
FIGURE 1:
Hone Quarry Dam in Rockingham County

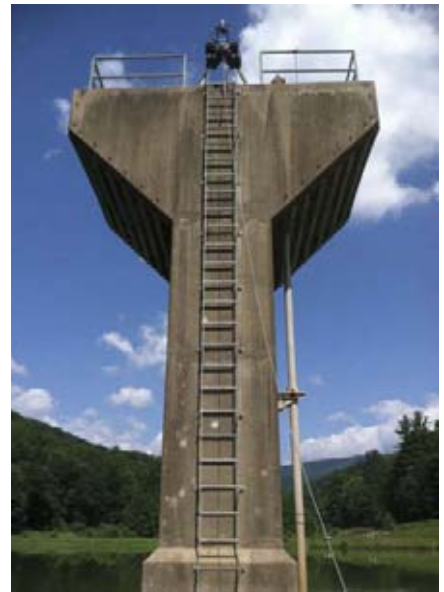
FIGURE 3: Hoisting inspection equipment onto riser structure
