**Date:** April 21, 2020

**From:** Carl Bundschuh, P.E., Randy Parks, P.E., and Konnor Bursaw, P.E. - Dewberry Engineers Inc.

**Subject:** p-CAT™ Pipe Wall Thickness Verification using High Resolution Eddy Current Testing

The City of Louisville owns a steel 16-inch diameter raw water pipeline that was installed in 1955, assumed to be 0.25-inch thick with a coal tar lining and coating. The City is replacing a small section of this pipeline to facilitate the installation of a valve vault. Because there have been issues with this pipeline in the past, the City has decided to take this opportunity to evaluate a new non-invasive pipeline assessment tool called p-CAT™. The p-CAT™ Pipeline Condition Assessment Technology used by Hydromax USA (HUSA) is a noninvasive, non-destructive pipeline condition assessment tool. The tool can be used as a screening tool to locate areas of reduced pipe wall thickness over thousands of feet of pipe. The technology was developed in Australia and has been used and validated overseas extensively, however, this is the first validation study undertaken in the United States since its introduction to the US market in 2017.

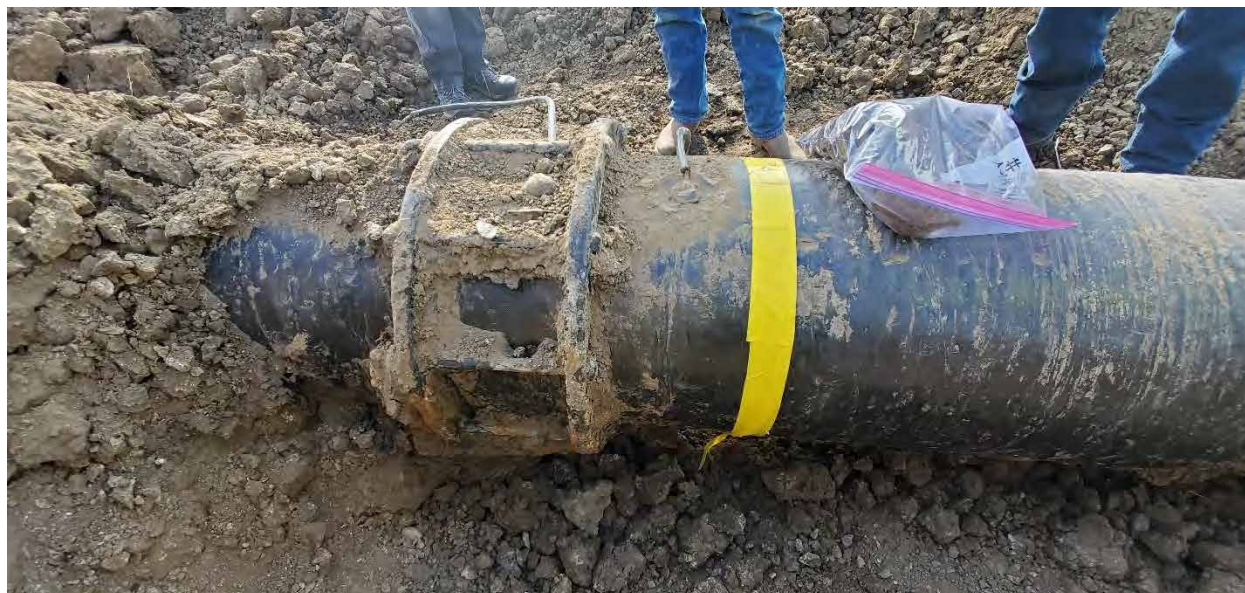
Figure 3 – Pipe and Coupling Conditions

The lining and coatings are both coal tar enamel. The coating was tested by the City of Louisville for the presence of asbestos and the results indicate no asbestos binders were used. The coating was intact around the circumference, with significant variation of coating thickness. The pipe showed very little external corrosion with only very minor surface corrosion under the pipe and around the coupling.

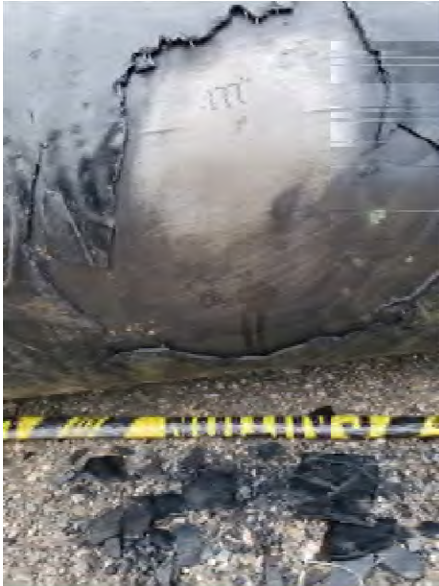
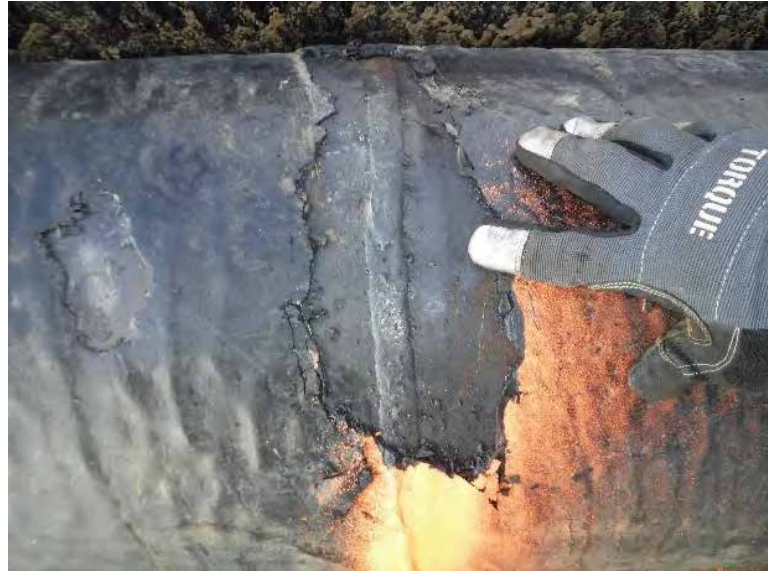
**Figure 5 & 6 – Outer Coating Removal to Check Bonding (orange color is from paint)**

In several locations, the coating was removed with a hammer to observe how well bonded the coating was, look for coating disbondment, and observe the presence of corrosion. The coating appeared to be well bonded to the pipe, with no visible corrosion observed in any of the locations coating was removed.

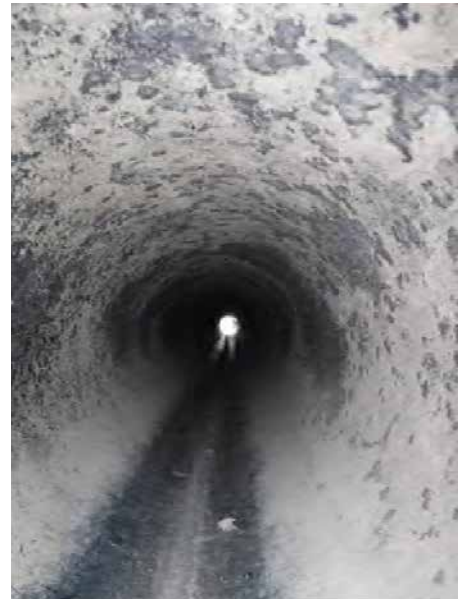
**Figure 7 – Interior of Pipeline**

The interior of the pipeline is coal tar enamel lined and is free from disbondment, pitting, rusting, or any signs of visible corrosion. The lining itself has no apparent spalling or cracking. The pipeline was cut into two pieces for removal and transportation from the project site to the City's Water Treatment Facility for further analysis. Sectioning the pipe in two places allowed Dewberry to observe the condition of the pipe interior at four locations. All interior pipe observation indicated an intact, well bonded lining with no visible interior corrosion.

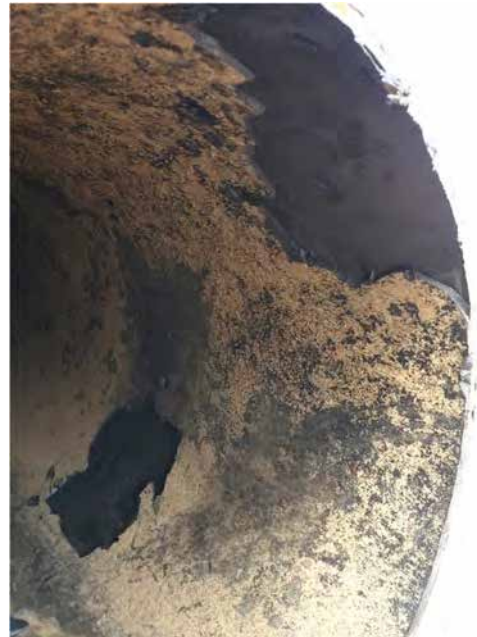
**Figure 8 – Interior Coating Removal to Check Bonding**

The lining was removed with a hammer in a few places to observe how well bonded the lining appeared, look for lining disbondment, and observe the presence of any corrosion. The lining appeared to be well bonded to the pipe, with no visible corrosion observed in any of the locations the coating was removed.

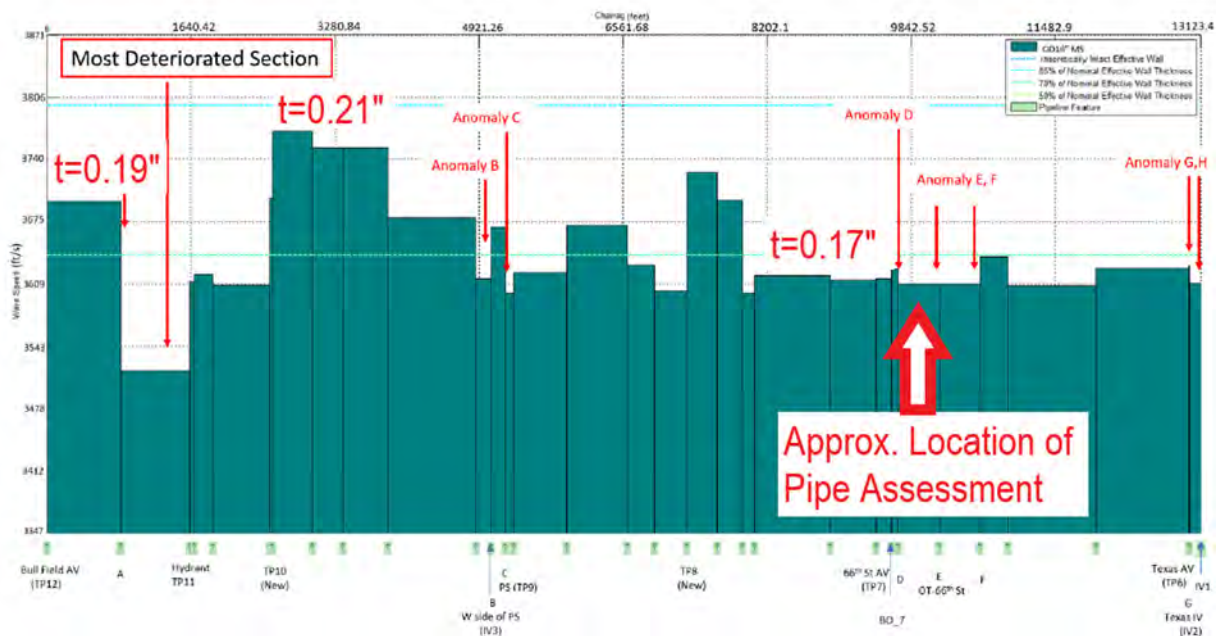
**Figure 12 – Wave Speed Variation Along the Pipeline**

The results of the p-CAT™ test determined varying levels of pipe deterioration had occurred on the Louisville Raw Water pipeline based on the varying wave speeds produced along the length of the pipeline as shown in Figure 12.

Figure from City of Louisville p-CAT™ pipeline Condition Assessment, included as Appendix A. Figure 12 assumes external corrosion with corresponding remaining wall thicknesses in inches indicated in red (example t=X.XX”).

The p-CAT™ report identifies the thickness for the section of interest (between Anomaly D and E) of pipeline to be 0.17 inches. This corresponds to 32 percent wall loss from the assumed original wall thickness of 0.25 inches. Percent degradation is based on client-provided information on original pipe wall thickness.

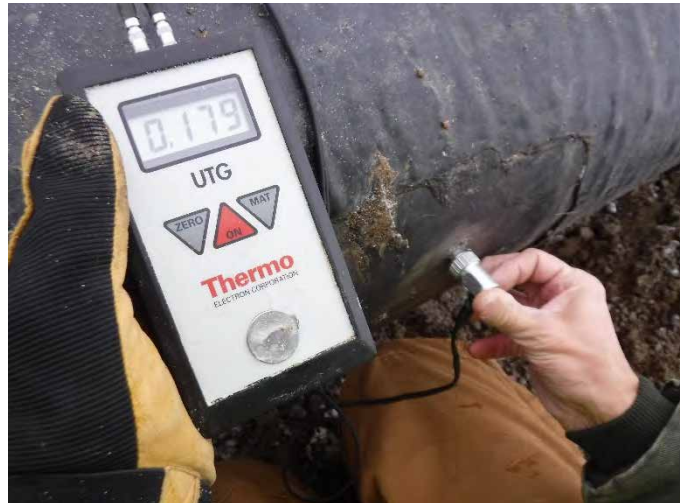
**Figure 13 – UTG Testing**

The UTG measurements were performed to verify the INCOTEST results. These measurements were performed intermittently along the pipeline, at crown, springline and invert. The thickness measurements ranged from 0.179 inches to 0.190 inches and are accurate to within  $\pm 0.004$  inches.

The UTG readings loosely correlate with the INCOTEST readings, varying an average of 0.008 inches. Additionally, comparing the UTG and INCOTEST results, the readings are not consistently different as the differences vary between 0.002 inches and 0.023 inches. The UTG readings do, however, confirm the pipeline thickness to be approximately in the range measured by the INCOTEST.

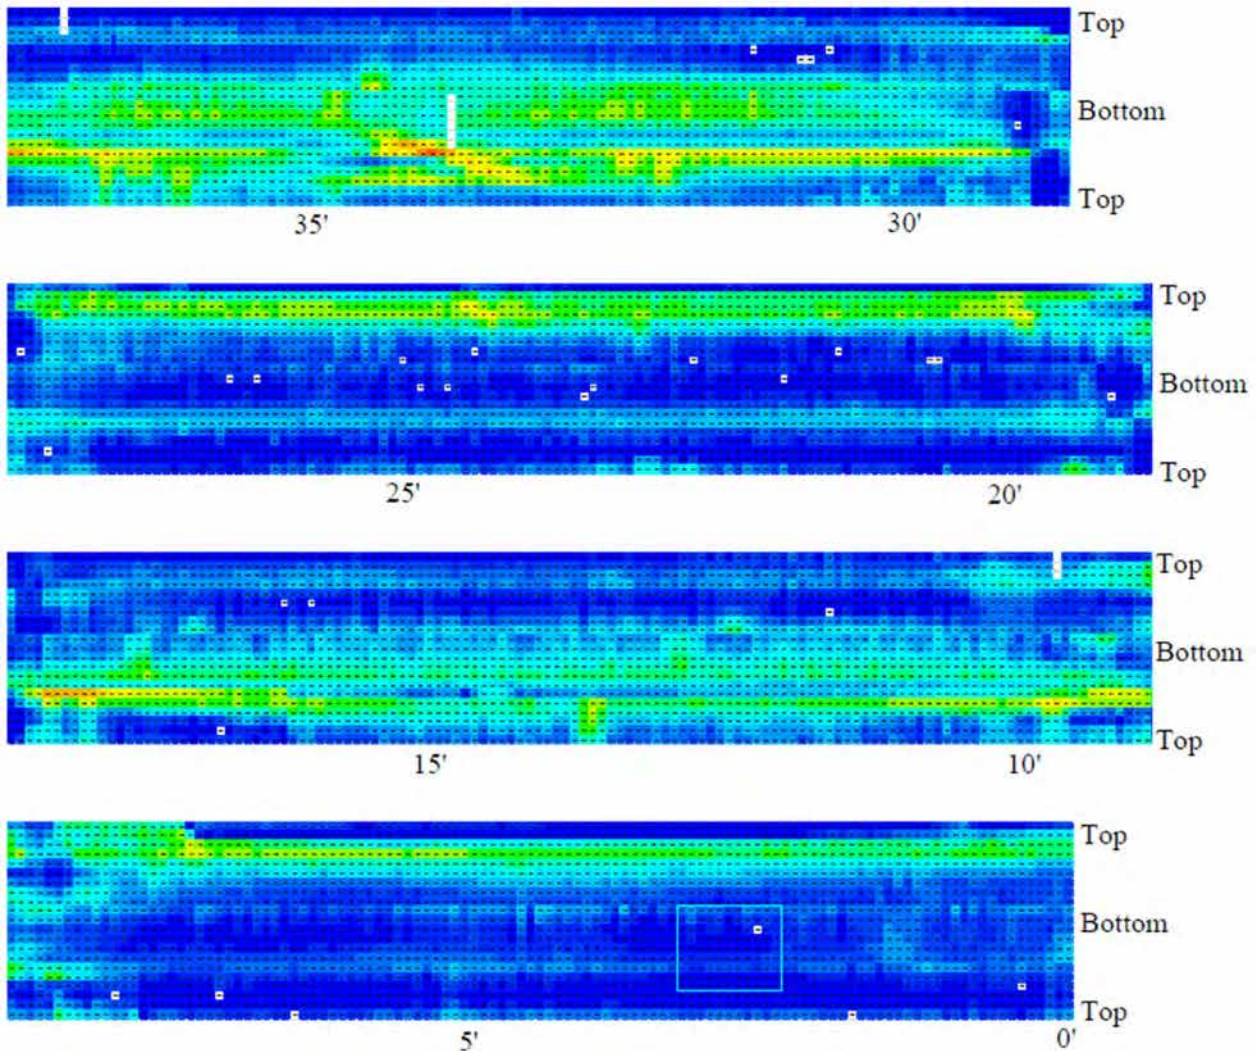
**Figure 14 – Four Pipe Sections' Relative Thicknesses, Graphically Separated at the Welded Joints**

The INCOTEST, spot ultrasonic thickness test measurements and the Hydromax USA p-CAT™ analysis all found the average thickness of the removed pipe to be approximately 0.17 inches, summarized in Table 4 on the next page. Hydromax USA p-CAT™ accurately measured the average wall thickness of pipe being investigated in this study at this location. Confirmation of the p-CAT™ analysis at a second location which could provide access to the pipe was attempted to further compare the results. This alternate location was an air-vacuum valve vault which p-CAT™ indicated a 0.19-inch wall thickness, however, the ground within the vault proved too difficult to expose the pipe with hand tools.
