Hydromax USA Identifies Potential Underground Water Pipeline Issues for Aurora Water in Colorado

UTILITY: Aurora Water partnering with CH2M

- 30-inch steel water main installed in 1966 – on N Havana Street
- 27-inch steel water main installed in 1956 – on S Peoria Street

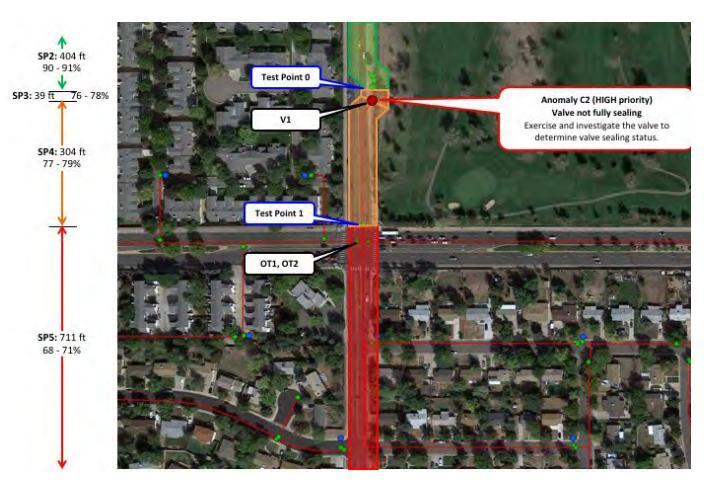
Sample Visual Summary of Sub-Section Analysis Report
