**CASE
STUDY**

Putting Nautilus™ to the test in the Navajo Nation

Characteristics of the sections inspected:

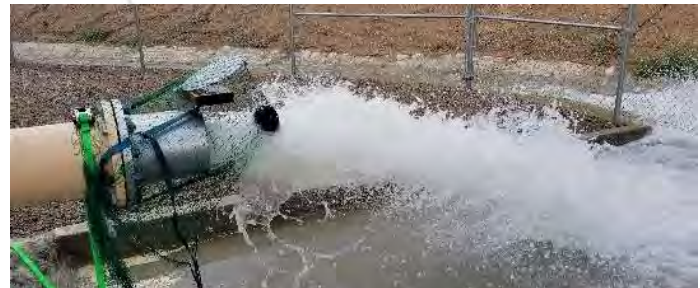
Encompassing the full internal diameter of the pipeline, the Nautilus System catch net is installed prior to any insertion. The proper placement and alignment of the net is verified using a built-in camera system allowing real-time verification for field crews.

Hydromax USA team launches Nautilus, typically via insertion at a vertical valve, and the sphere is released into the flow of the water. Nautilus creates an audio recording as it moves with the flow of water.

Neutral buoyancy provides Nautilus the most optimal means of traversing the pipeline. Traveling in the center of the pipe allows Nautilus to avoid many obstacles including sediment build up and more easily navigate butterfly valves. Additionally, traveling in the center of the pipe allows Nautilus to utilize the most efficient velocity provided by the pipeline.

Prior to inserting the Nautilus System, the Hydromax USA team places synchronizers at intermediate locations along the pipeline using existing accessible features such as hydrants, valves, etc. The synchronizer devices serve as reference points for the Nautilus sphere as it traverses the pipeline and help to optimize the accuracy of the results.

Once Nautilus has reached the end of the test, the team is alerted via camera and an alert system. It is captured in the net and safely removed from the pipeline.

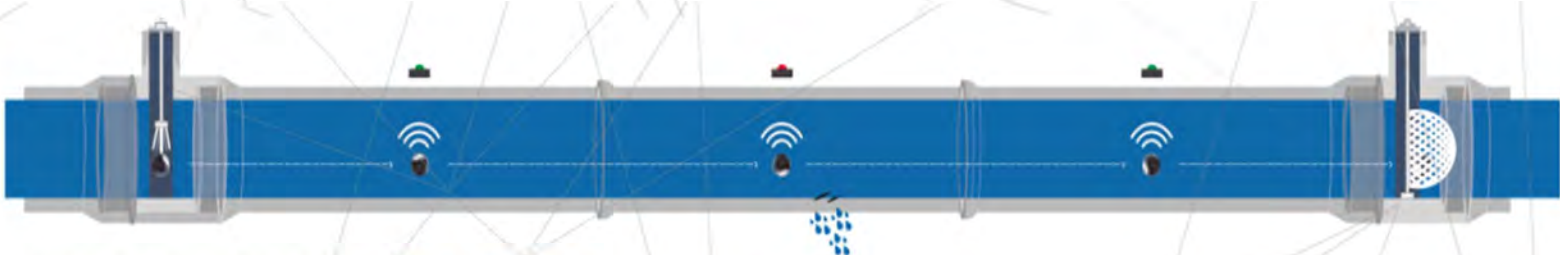
Once the sphere is extracted, the recorded sounds are processed and analyzed using the Nautilus Systems' proprietary algorithms. (The data contains different spurious noises that are filtered by several processing techniques.) The final inspection report provides for each identified leak, gas pocket, and anomaly a range of observations, including but not limited to:

- Acoustic recording supported by visual plot (Colorimetry) of the identified discrepancy.
- Prioritization level for each identified leak.
- GPS /GIS deliverable of all findings and all project appurtenances in ESRI compliant format.
