**Date:** April 21, 2020

**From:** Carl Bundschuh, P.E., Randy Parks, P.E., and Konnor Bursaw, P.E. - Dewberry Engineers Inc.

**Subject:** p-CAT™ Pipe Wall Thickness Verification using High Resolution Eddy Current Testing

The City of Louisville owns a steel 16-inch diameter raw water pipeline that was installed in 1955, assumed to be 0.25-inch thick with a coal tar lining and coating. The City is replacing a small section of this pipeline to facilitate the installation of a valve vault. Because there have been issues with this pipeline in the past, the City has decided to take this opportunity to evaluate a new non-invasive pipeline assessment tool called p-CAT™. The p-CAT™ Pipeline Condition Assessment Technology used by Hydromax USA (HUSA) is a noninvasive, non-destructive pipeline condition assessment tool. The tool can be used as a screening tool to locate areas of reduced pipe wall thickness over thousands of feet of pipe. The technology was developed in Australia and has been used and validated overseas extensively, however, this is the first validation study undertaken in the United States since its introduction to the US market in 2017.

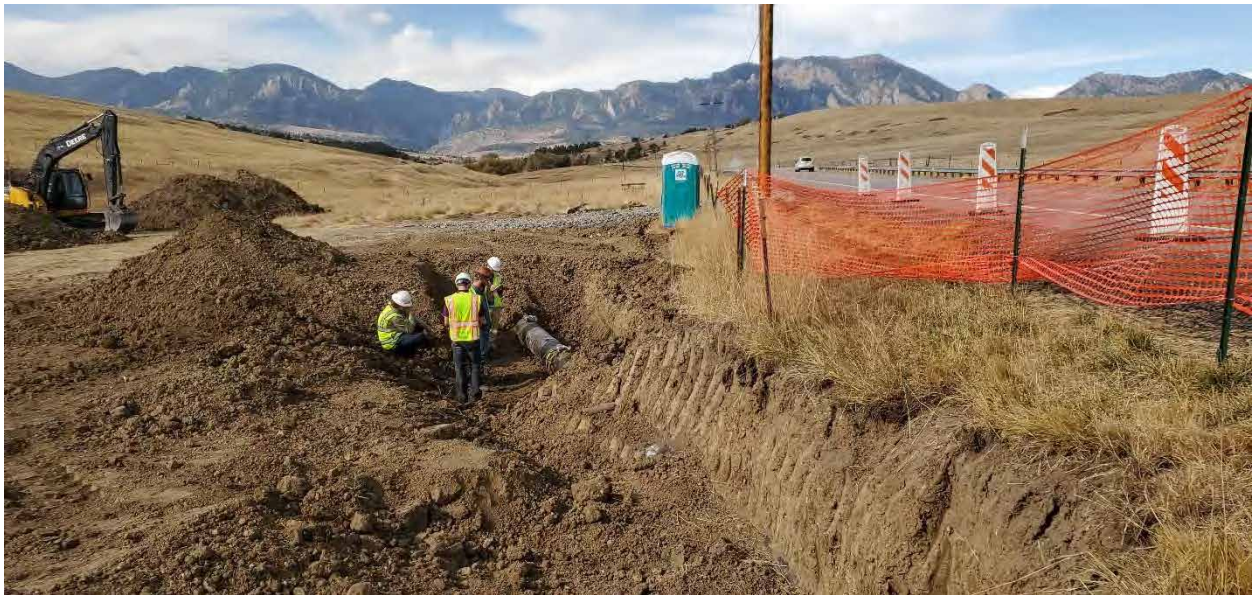
**Figure 2 – Excavation Site**

and crosses Marshall Road to the northeast. Soils adjacent to the pipe were dry, sandy-clay soils. Three soil samples were taken along the trench at the pipe elevation and a soil corrosivity analysis performed. Results of the test ranged from mildly corrosive to corrosive as found. When saturated, the soils ranged from moderately corrosive to very corrosive. The results of the soil analysis are presented in Appendix C.

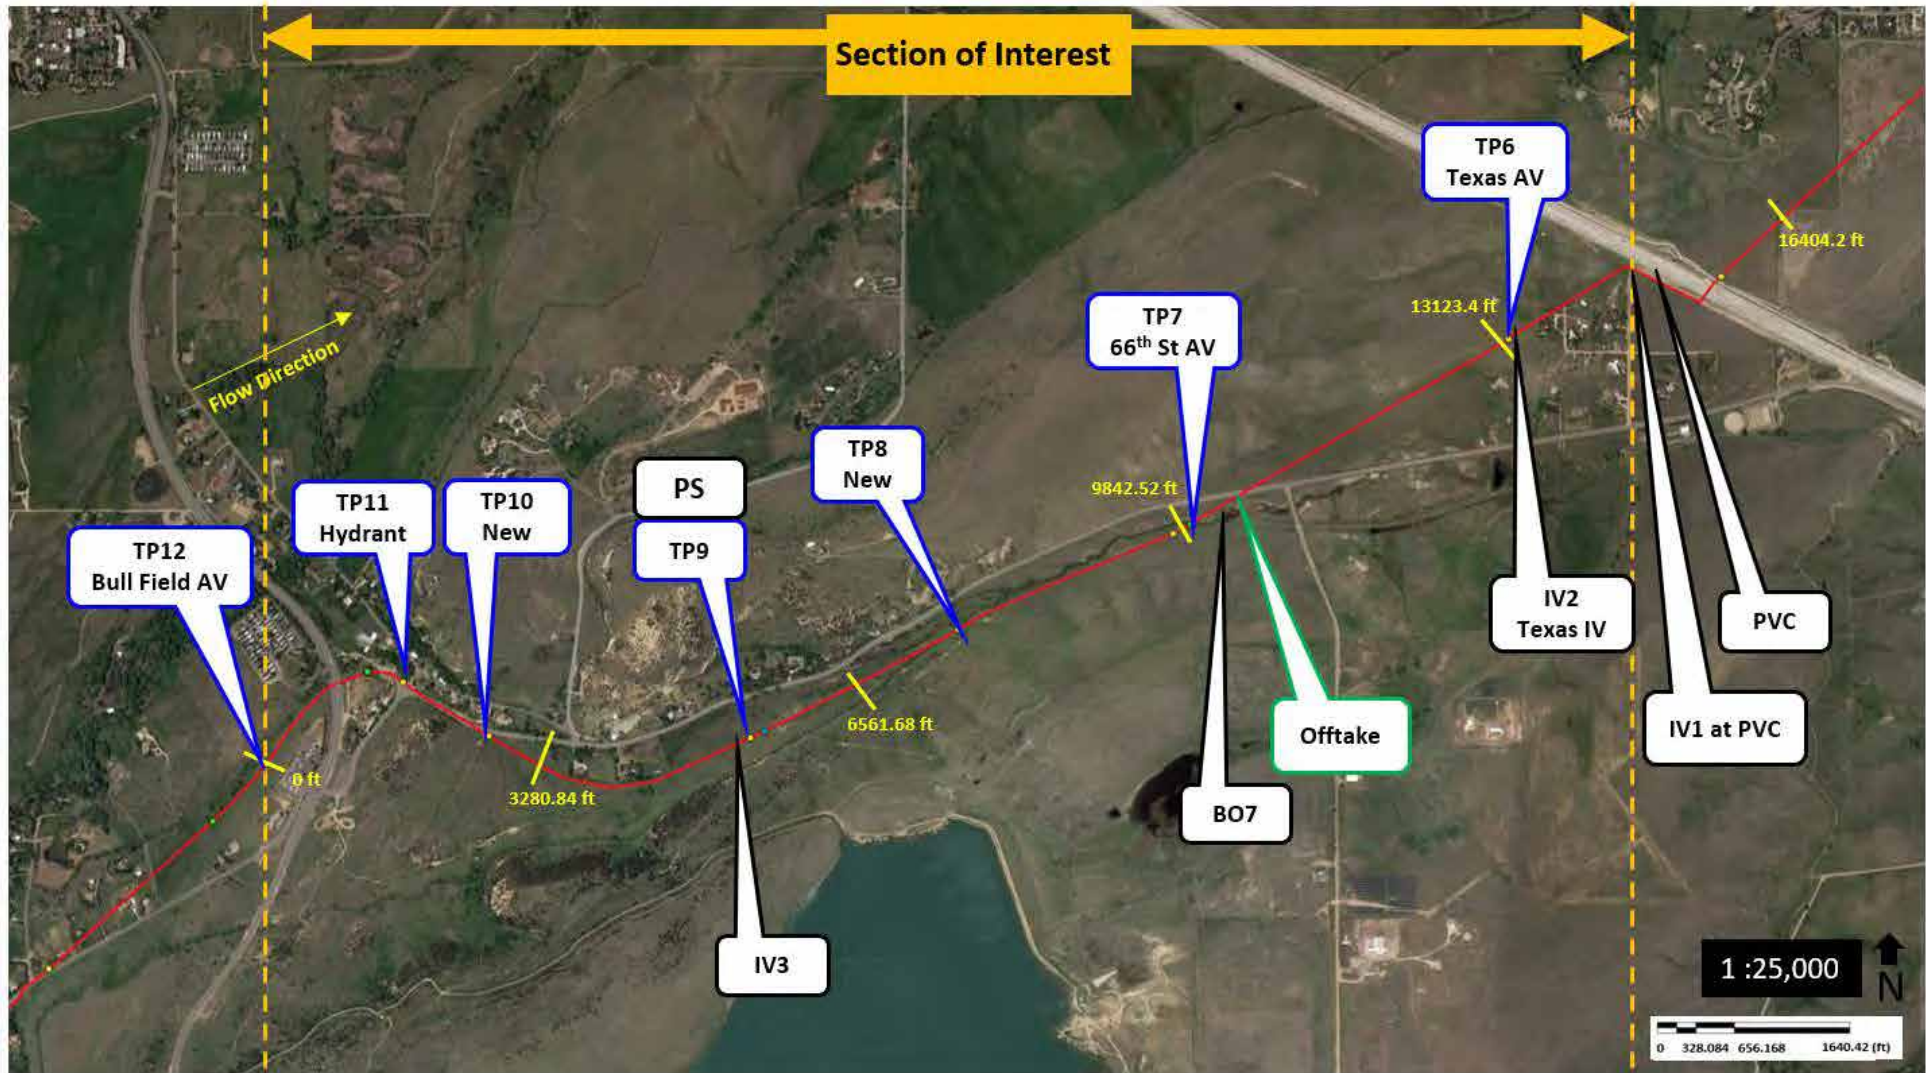
Figure 1.1: 16-inch Tar Lined Steel Pipe, the Louisville Raw Water line section of interest.

The pipe material, lengths and features of the Louisville Raw Water line and their locations are listed in Table 1.2, and shown in Figure 1.1.

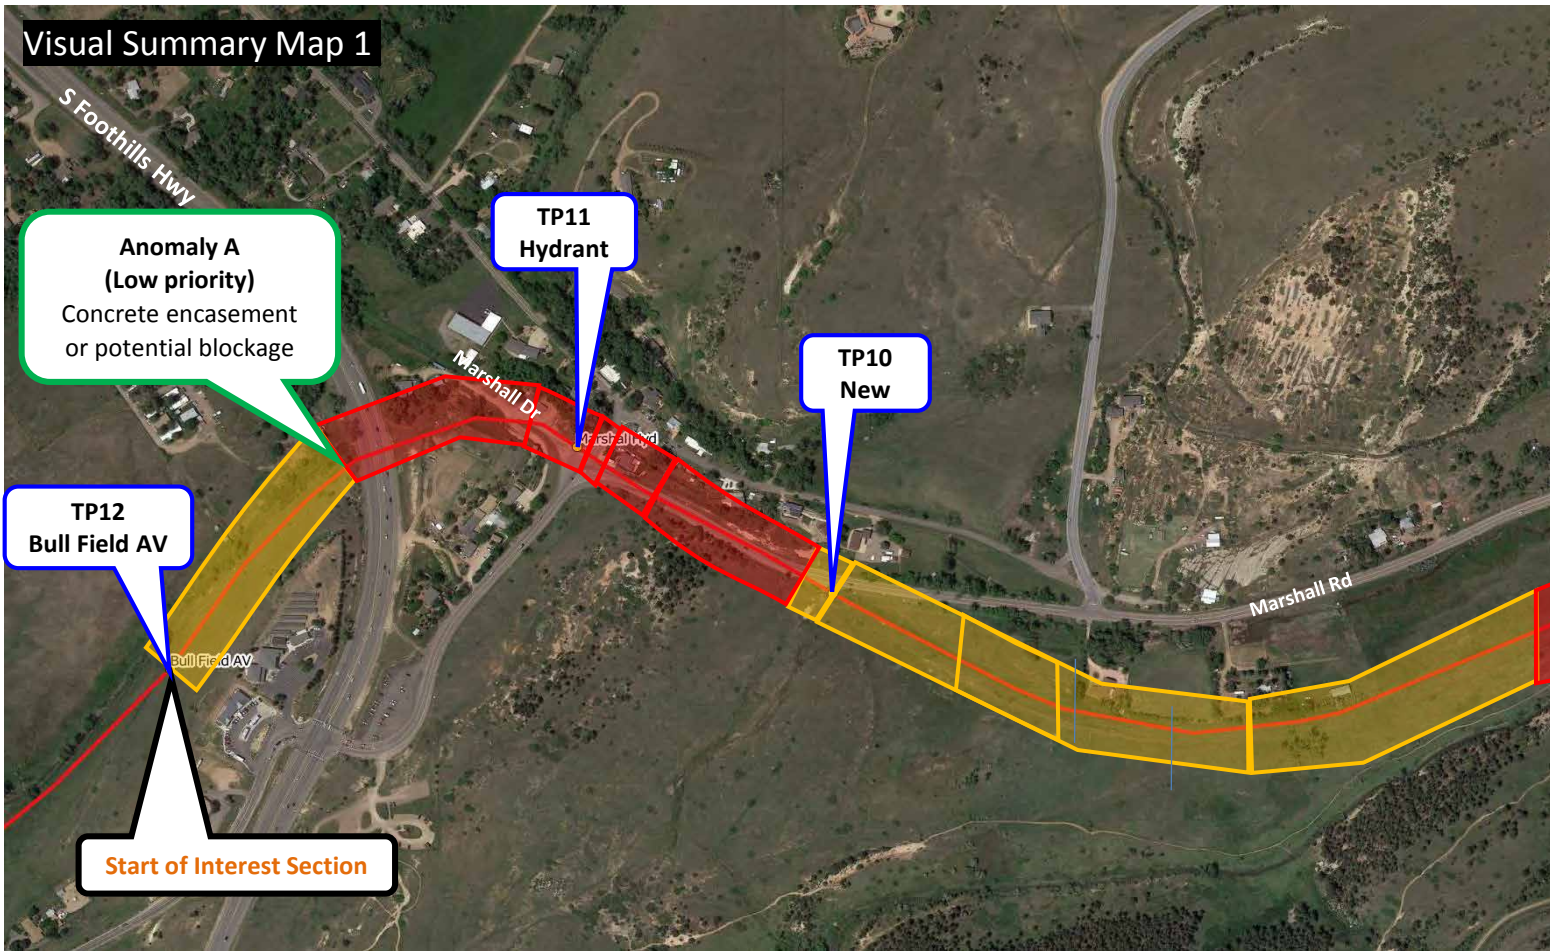
Please refer to Table 1 for the recommended action regarding high and medium priority anomalies and Table 2 for remaining wall thicknesses
