# HYDROMAX USA Advanced Water, Wastewater and Gas Data Collection

# Hydromax USA Aids the City of Virginia Beach, VA with Pipeline Replacement & Rehab Project

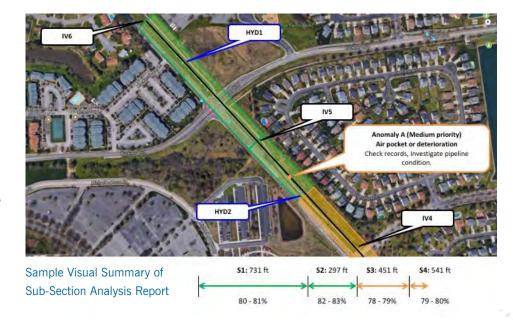
- 32% of pipeline tested was HIGHLY DETERIORATED
- 65% of pipeline tested was MODERATELY DETERIORATED
- 2 HIGH PRIORITY and 11
   MEDIUM PRIORITY anomalies
   were identified which included
   valves that were not fully sealed,
   pipe material change and
   entrapped air.

The data was sent to the analysis team for detailed review and report generation. Utilizing assumed originally installed pipeline schedule and class, the analysis team performed a sub-sectional analysis to identify problem areas down to 30 ft. resolution.
