p-CAT™ Goes to Infinity and Beyond in Clearwater, Florida

CASE STUDY

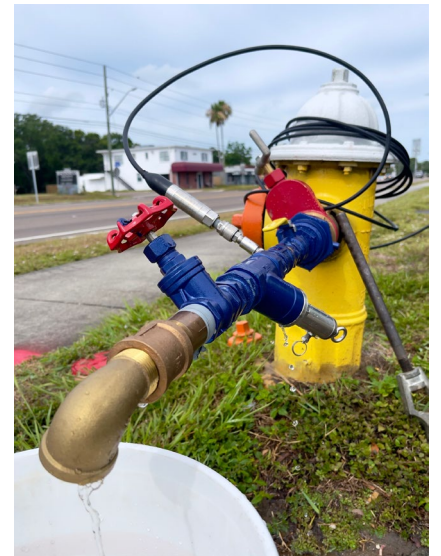
The new p-CAT™ Infinity methodology is specifically designed for inspections of 6-inch to 16-inch mains where the main doesn't need to be isolated and equipment can be deployed via fire hydrants and 1-inch taps.

Deploying updated equipment, the new p-CAT™ Infinity methodology is specifically designed for inspections of 6-inch to 16-inch mains within water distribution systems. In contrast to the traditional p-CAT™ methodology, the water main does not need to be isolated, and equipment can be deployed via fire hydrants and 1-inch taps. The project location was ideal for testing these parameters as there were operable hydrants within 300 – 1,000 feet, and most offtakes could be isolated without impacting water supply to nearby residents and businesses.
